Re: Lifting Platforms – Vimec E10 EcoVimec

Maintenance Interventions - Technical note for maintenance engineers

Technical bulletin No. 02/2021

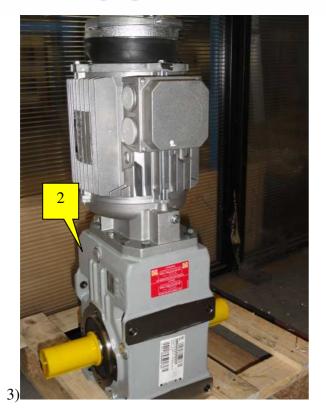
Togliere il tappo indicato (1) Remove the oil filler cap (1)

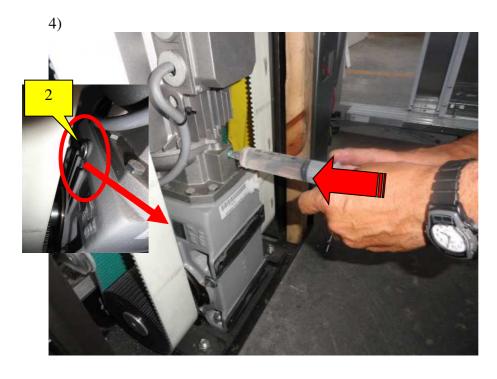
Svitare leggermente il tappo 2 per verificare se esce olio. Se esce olio, richiudere, e passare al punto 5. Se non esce olio svitare completamente il tappo e passare al punto successivo 4.

Unscrew slightly cap No. 2 to check if oil flows out, tighten it again and go to point 5. If no oil flows out unscrew the cap thoroughly and go to point 4.

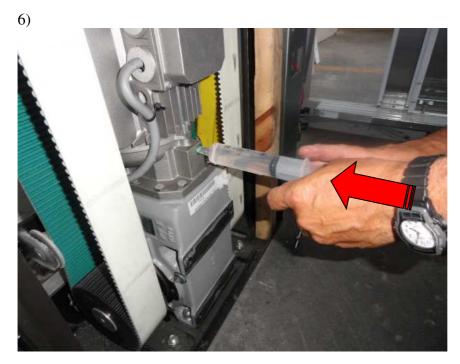
Dopo che si è visto uscire l'olio dal tappo n.2 rimontare e serrare il tappo.

After seeing oil flowing out from cap No. 2 put the cap in again and tighten it.

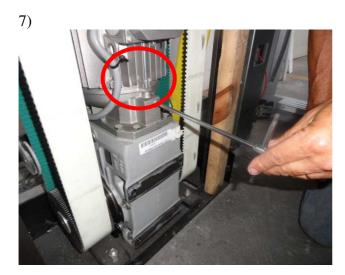
Dopo aver richiuso il tappo n.2 aggiungere 150 cc di olio ulteriori dal tappo n.1.

After tightening cap No. 2 pour 150 cc oil additionally through cap No. 1.

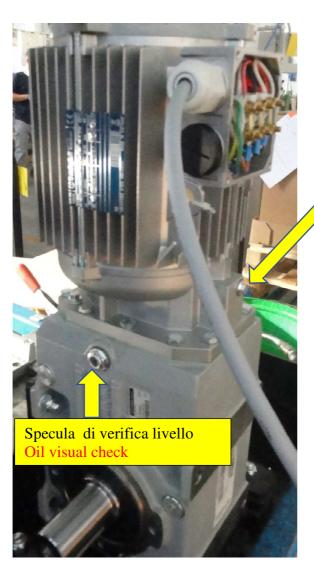
8)

Motoriduttore fornito dal 2014

Gear Box supplied from 2014
