TECHNICAL SAFETY BULLETIN: DEVE CAR TOP INSPECTION CONTROL

Re: Deve Car Top Inspection Control

Identification of Deve DQ Control Systems

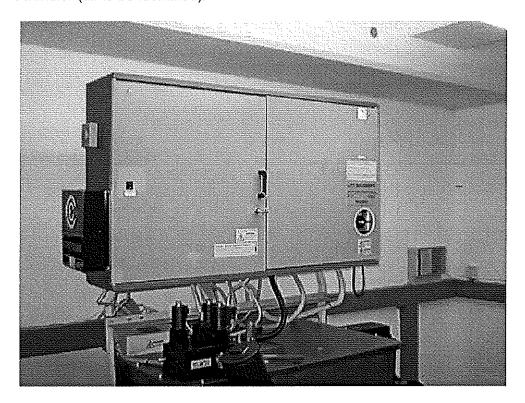
The Deve DQ control cabinet is mounted above the machine room hydraulic tank. However, lifts using this control system were installed under the names Deve, Deve Schindler and Schindler (all to be identified).

In order to prevent the above, Schindler recommends the replacement of both the car top inspection switches (IS & IK) on all lifts installed before 1st July 1999 with a Deve DQ control system.

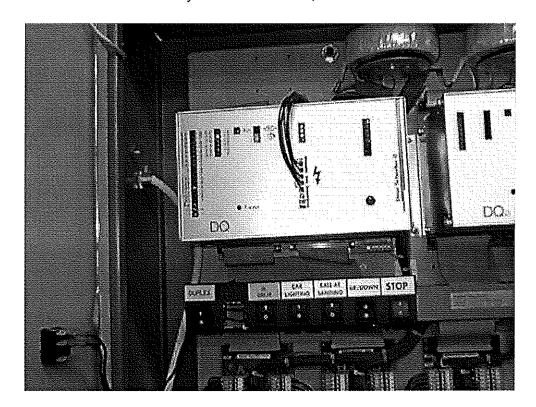
The cover on the PCB bay within the cabinet, is marked DQ.
